New Primark Rotterdam

Thursday, 13 February 2014

Prepared for Akor

Identified 17 Issues
Ian Guest

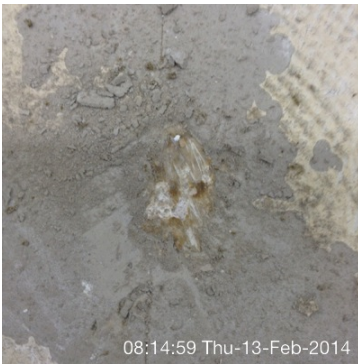
Ground Floor

2mm levelling compound onto ceramic tile

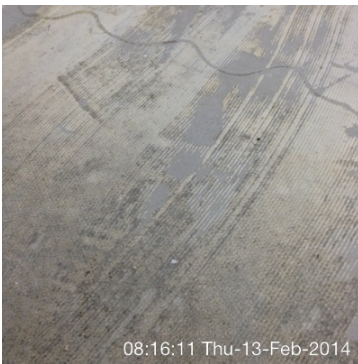
Ground Floor

Adhesive residue to surface of levelling compound

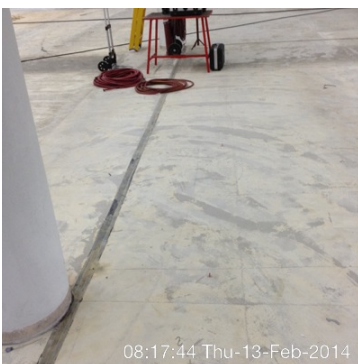
Ground floor

Expansion joint with EJC over top. Joint is off set

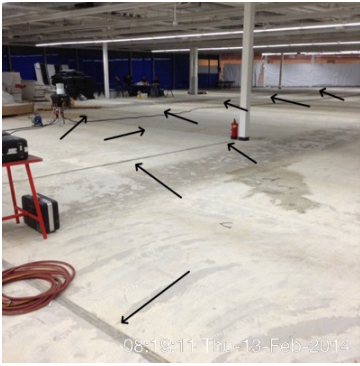
Ground floor

Joint detail

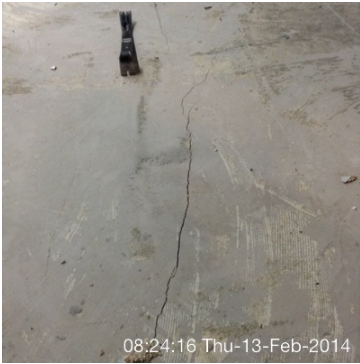
Ground floor

Crack by front entrance

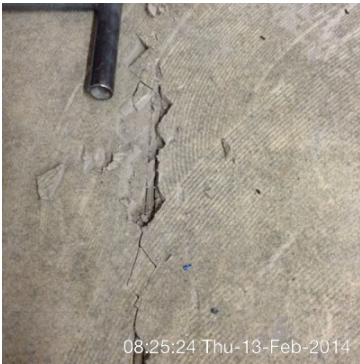
Ground floor

Crack over joint screed 10-15mm thick

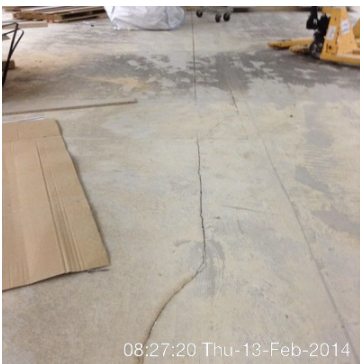
Ground floor

Movement joint screened over

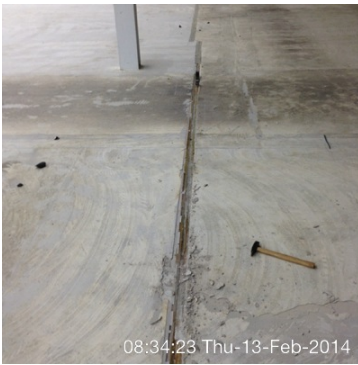
First floor

Expansion joint higher on left side. Levelling compound applied over ceramic to left of joint

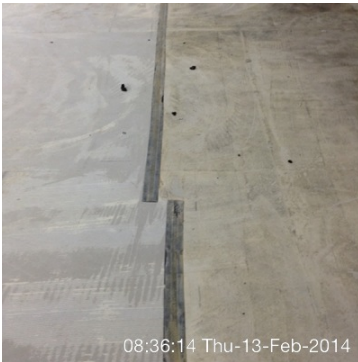
First floor

Expansion joint off set !

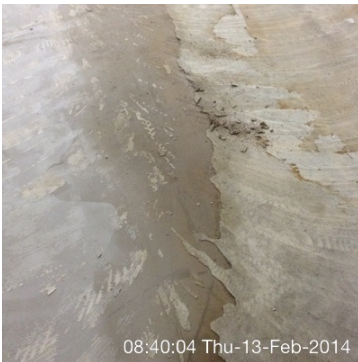
First Floor

Damp patch leveller starting to loosen

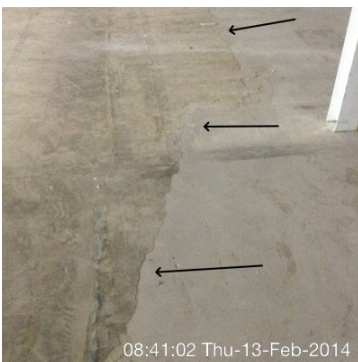
First floor

Leveller onto leveller

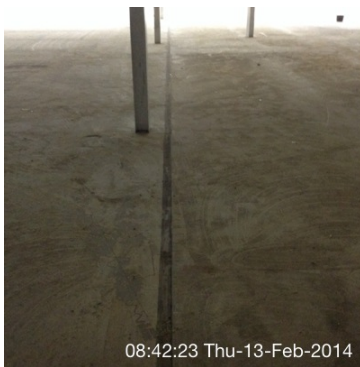
First floor

Expansion joint

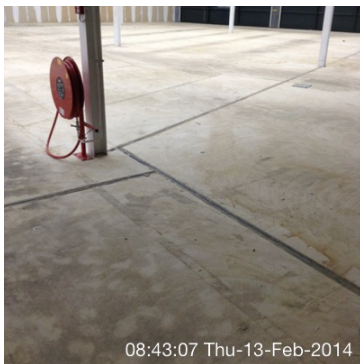
First floor

Expansion joint meeting centre of floor

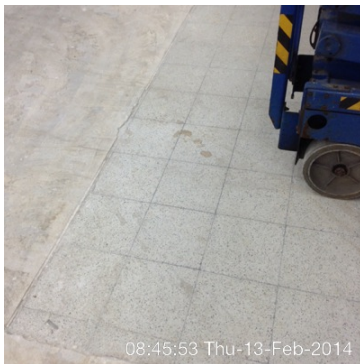
First floor

Tiles

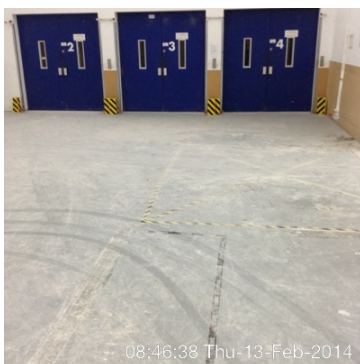
First floor

Resin by goods lifts

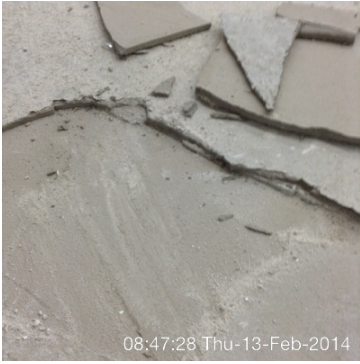
First floor

Patch repair failed 10-12mm approx 1m2
